Report on the breaking of a girth-hitched sling, with recommendations for usage of connected slings

Conducted by Mammut Sports Group, Seon, Switzerland. 1/10/2007

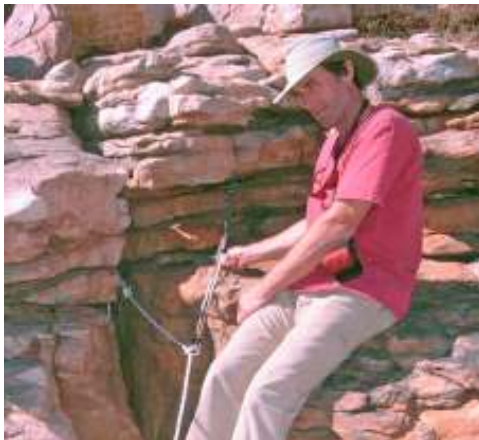
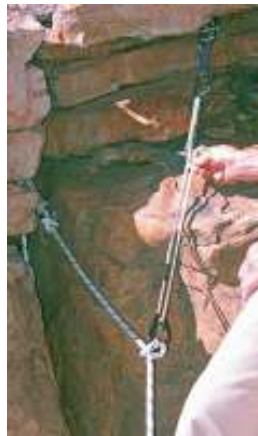
Fig. 1. The anchor in question on 10/22/06, showing the configuration of the slings

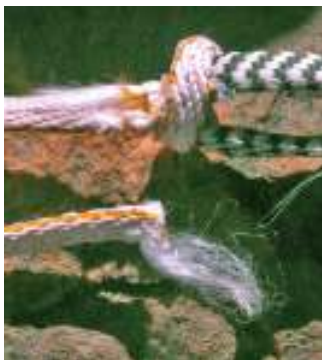
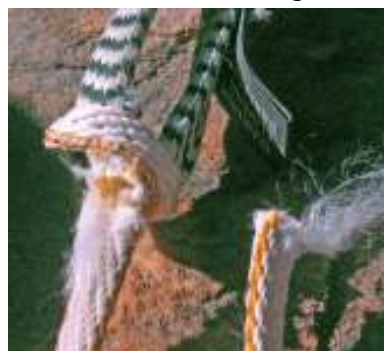
Fig. 2. Photos of the break taken at the site of the accident

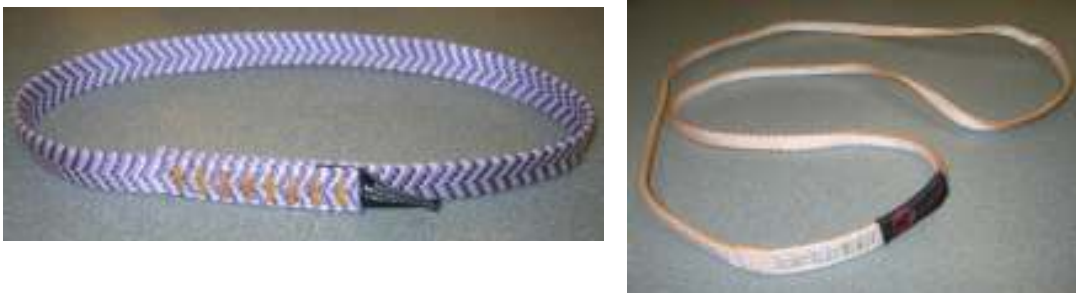
Fig. 3. Misty Mountain 15mm Spectra sling, strength 3097.5 DaN; and Mammut 8mm Contact sling, strength 2308DaN.

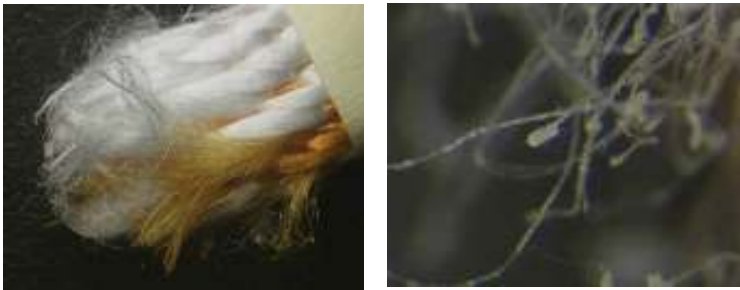
Fig. 8. A picture of a typical break produced by a static pull. Note the uneven nature of the break and the melted ends and melted together areas of the individual fibers

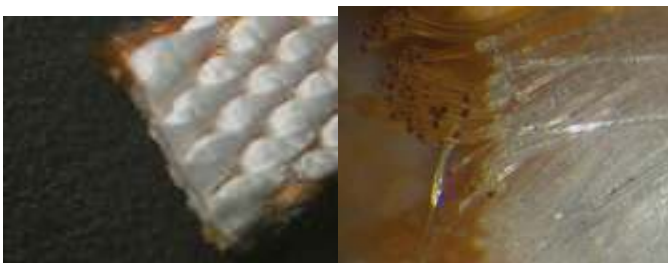
Fig. 12. A typical sling broken over a sharp edge. Note the uneven break and the melting of the ends and melted-together fibers

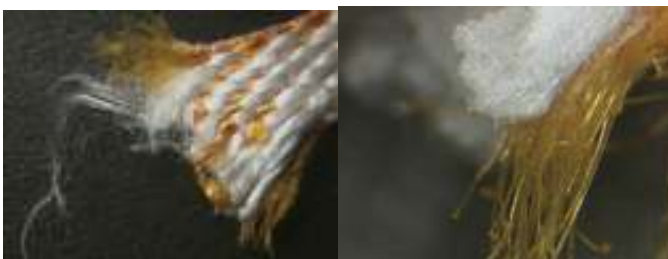
In addition, one photo (Fig. 13) was taken of a sling broken because of an acid contamination. Because the Sherman sling showed none of the deformation associated with this contamination, chemical analysis of the sling was considered unnecessary.

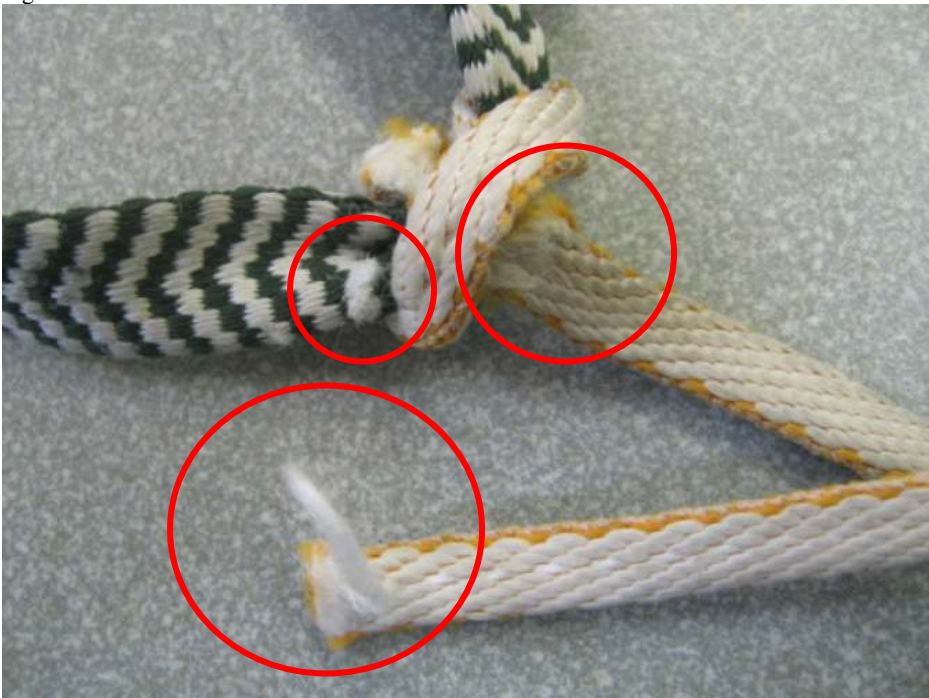
Fig 14b. Broken part of the sling. The break is diffuse, and clearly linear, with one pulled strand. There is no melting of the individual fibers visible.

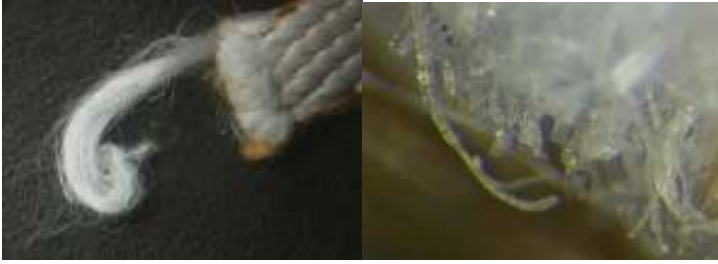
Fig 14c. Damaged part of the sling. Fibers on top of the sling are broken. There is no melting of the fibers.

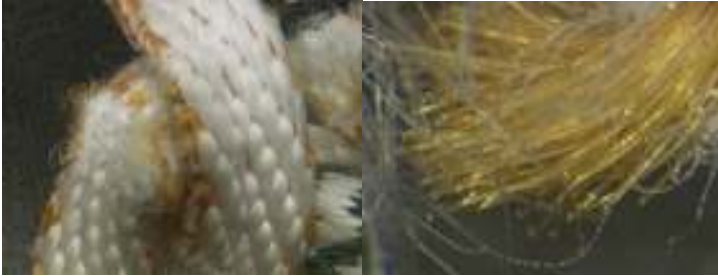
Fig 14d. Torn Spectra sling. The Spectra sling is torn about 0.5cm. The break has very linear characteristics, with no melting.

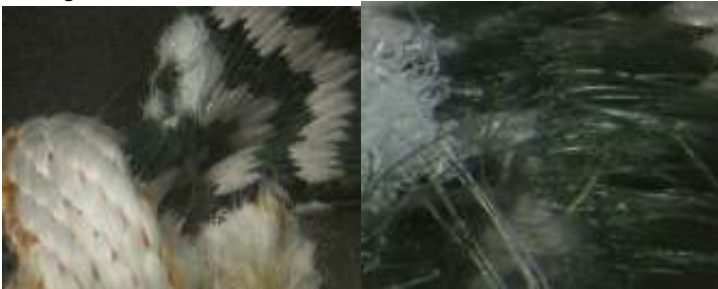
When comparing the photos of the tested slings, it is noteworthy that in all the test slings broken under load, there is significant melting of the ends of the fibers, and often melting together of the fibers—the two exceptions are the two cut slings. In addition, the colored Polyamide (Nylon) cross thread, also called “shot”, is sheared in all the breaking pictures except the cuts.
